Schwindt & Company
7714 Carroll Avenue
Takoma Park, Maryland 20912
301 270-3554 www.schwindtco.net
email rob@schwindtco.net
MD Licensed, VA Certified
ASHI, FREA and NEHA Certified

Inspected 3/10/09 9:30am

Record 031009.1 - Herriman, John 400 Whittier Street, NW, Washington, DC

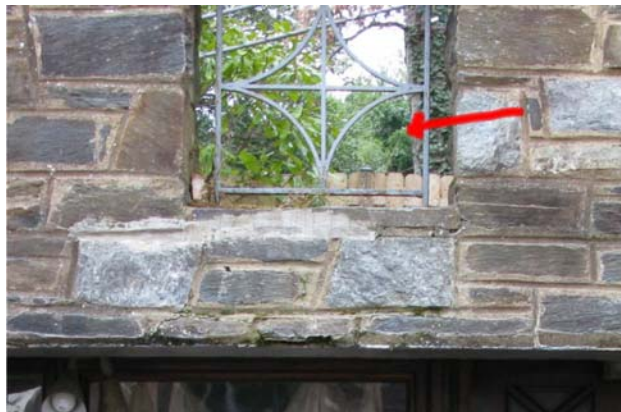
There is a stone wall at the end of the patio to keep people from falling down to the driveway below. There is an open section of this wall that has been filled with metal railing. The gaps in the rails are wide and small children could fall through (safety). The rail needs scrape and paint also.

The gaps in the rails are wide and small children could fall through (safety). The rail needs scrape and paint also.

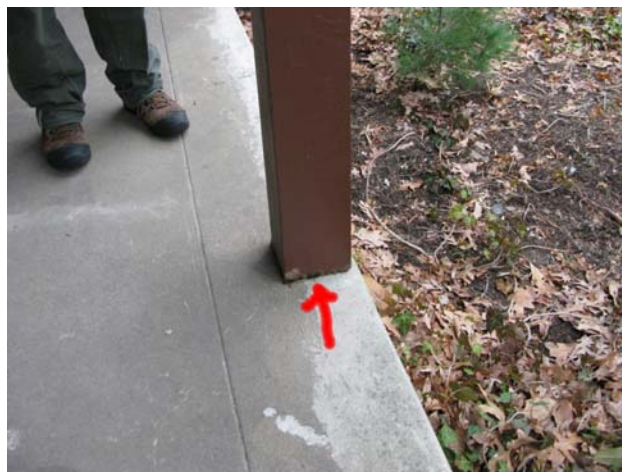
The center roof support post on the porch has rot damage where it rests on the porch floor. This post is not carrying load and needs carpentry repairs.

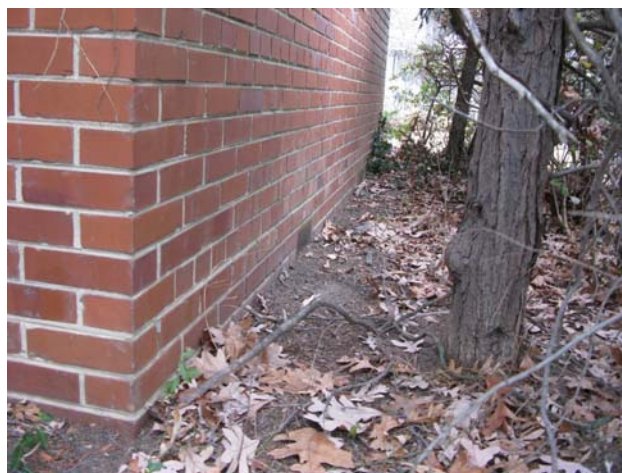
Tree/s closer than ten feet to house needs to be removed to prevent damage to House structure. Two at right side.

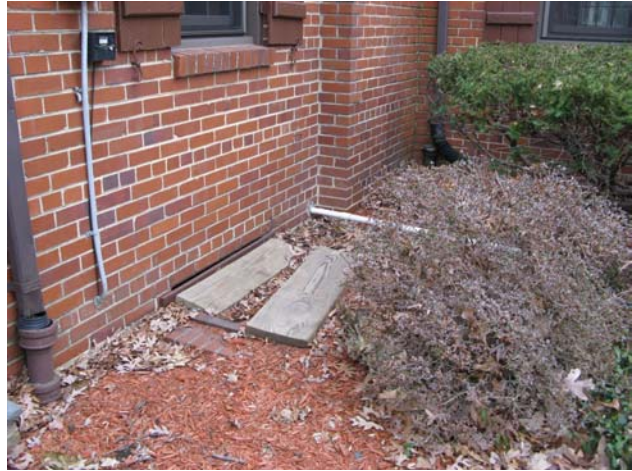
Water standing next to the house can increase risk of water entry and can over time cause damage to foundation.

The front center window well needs to be made taller to permit fill dirt to be added for grading improvement.

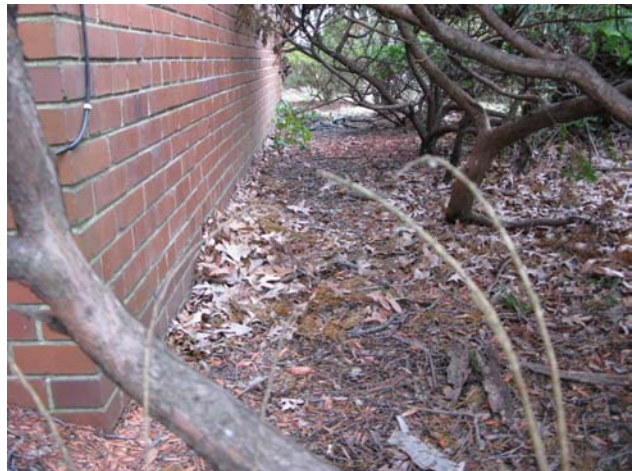
Grading is reversed next to the house at: Front right and right sides of the house. Window wells need to be added at the three crawl space vents to permit fill dirt to be added. The ground needs to slope away from the house at all sides.

Front right and right sides of the house. Window wells need to be added at the three crawl space vents to permit fill dirt to be added.

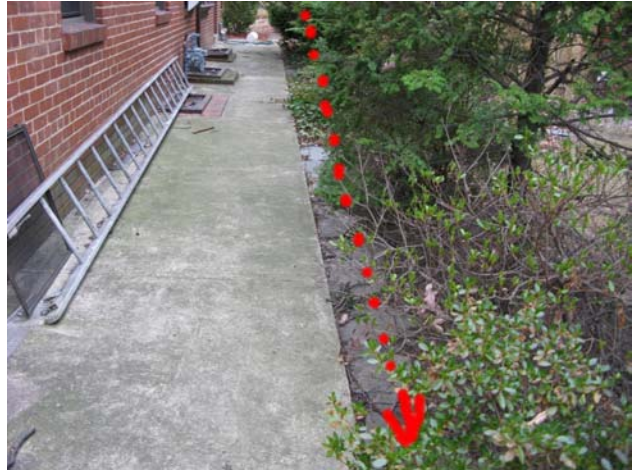
There has been some rear basement seepage in this area. Seepage could be due to standing water.

A yard swale or perimeter in ground drain needs to be installed all along the rear yard property line. This drain or swale will collect and move ground water away from the buildi

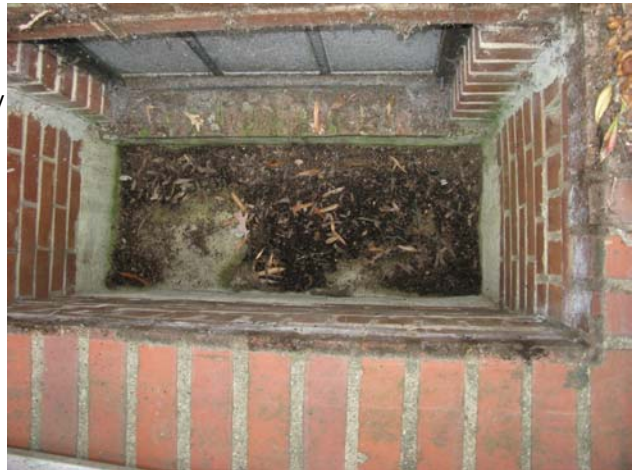
All window well bottoms need to be cleared of debris. Drains were seen in the bottoms of some wells. When cleared it may be discovered that all wells have drains.

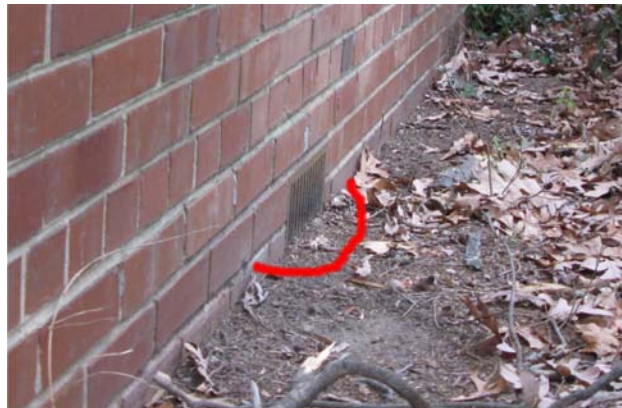
Window Wells Needed At: Crawl space vent grills at front right and right sides of the house. The vent grills are even with or buried into the yard grade at these areas. There are signs of seepage into the crawl space at the grills. Once the small window wells are added here, then additional fill dirt can be added next to the house for grading improvements.

Window Wells Needed At: Crawl space vent grills at front right and right sides of the house.

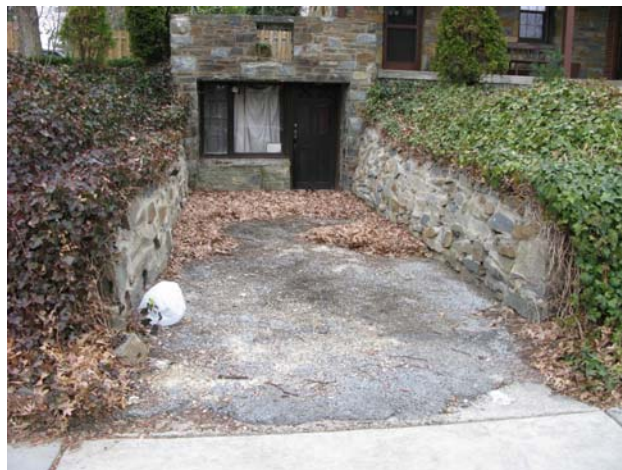
Some cracking noted in driveway.
Aged Asphalt, with cracking, sagging and deterioration.

Aged Asphalt, with cracking, sagging and deterioration.

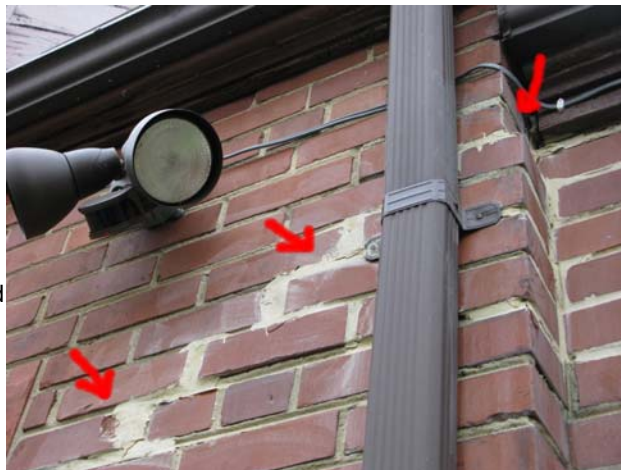
Cracking and house brick wall motion was seen at the rear corner of the house where main house connects to the dining room, kitchen wing. The house brick wall has moved 3/4 inch at this area. The cracking is seen up high on the wall. This is a structural defect. This wall motion has not put the house at current risk of failure. The cracks have been filled with mortar to stop water entry.

The inspector is not a structural engineer. The inspector is not sure what dynamic has caused this type of cracking. The buyer might want to get further evaluation by a licensed engineer. Even though the house is not at current risk, should the wall continue to move some expensive structural repairs could be needed.

Cracking and house brick wall motion was seen at the rear corner of the house where main house connects to the dining room, kitchen wing.

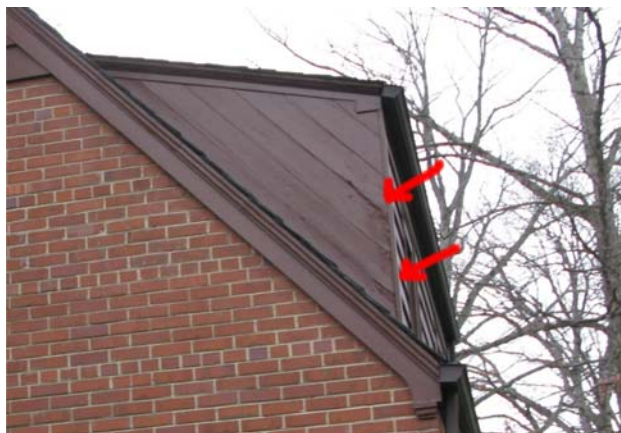
Some shed dormer wood siding has rot damage and repairs are needed.

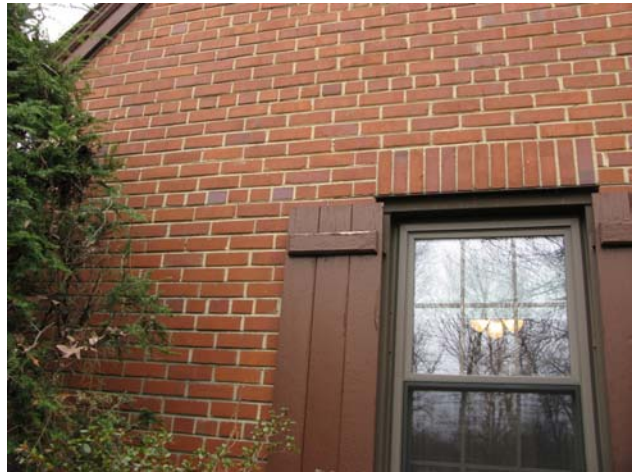
House shutter have flaked paint. Other house trim has flaked paint. All house wood trim should be painted to prevent rot damage.

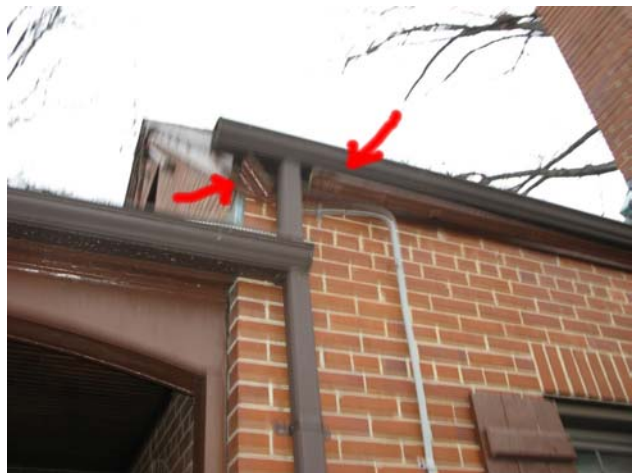
Several sections of fascia rake trim are loose and may have rot damage. House front and right sides. Repairs and paint needed.

All fascia, gutter boards and soffit should be inspected and repaired as needed to be in normal condition by a licensed contractor.

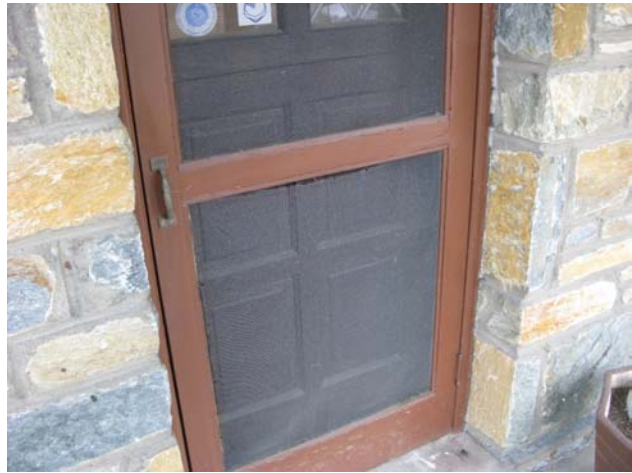
Kitchen front door was locked. No key available. The screen door here has torn screen. All doors should be operational and all keys provided.

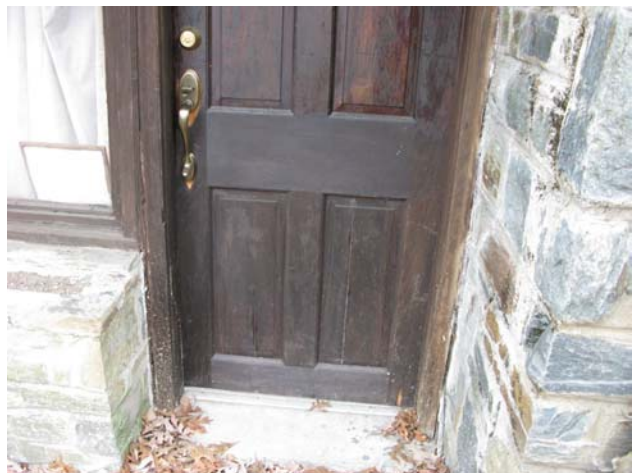
Basement door has some cracking which needs caulk repairs. The door and trim needs to be painted. The trim to wall joints need to be caulked.

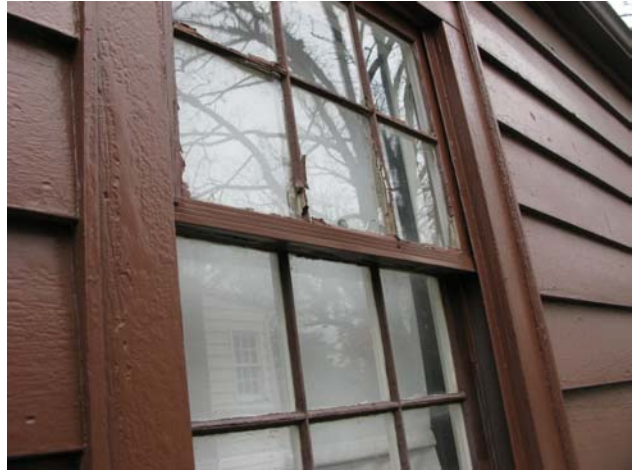
Lower house windows have been replaced with modern insulated windows.
The upper house wood windows have extensive rot damage and need to be replaced also. Very poor condition.

The upper house wood windows have extensive rot damage and need to be replaced also.

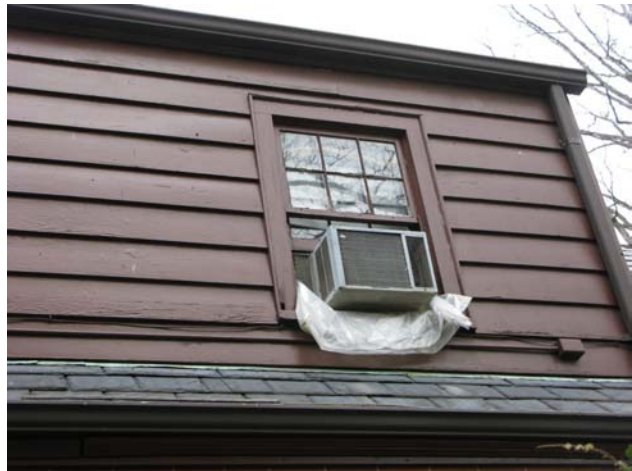
Additional picture

The upper house wood windows have extensive rot damage and need to be replaced also. Very poor condition.

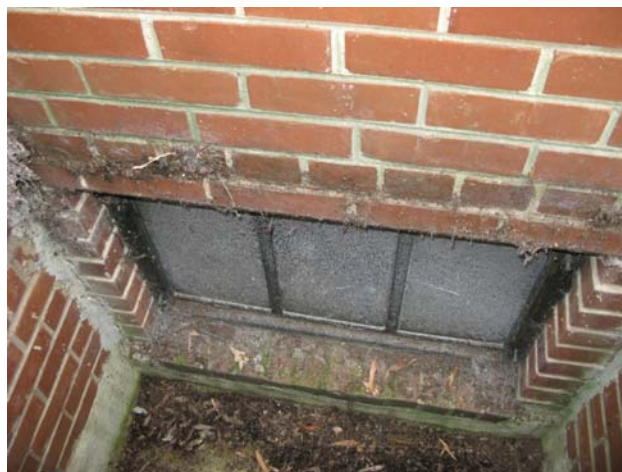
Old metal windows typically operate poorly if at all. For easy operating basement windows, replacement is typically needed.

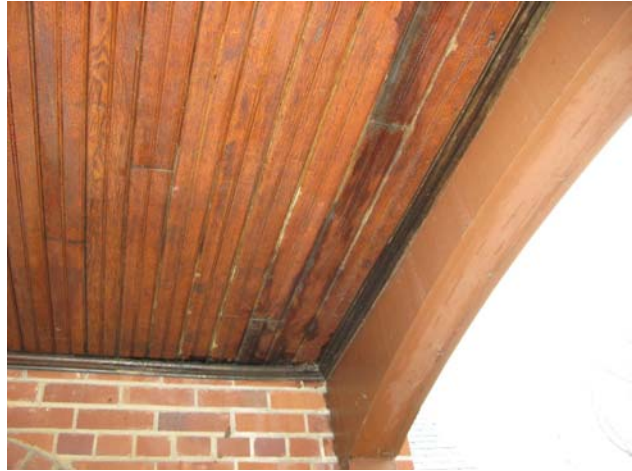
Front porch roof has been leaking at the lower right corner.
Roofing repairs are needed. The roof sheathing may be damaged here.

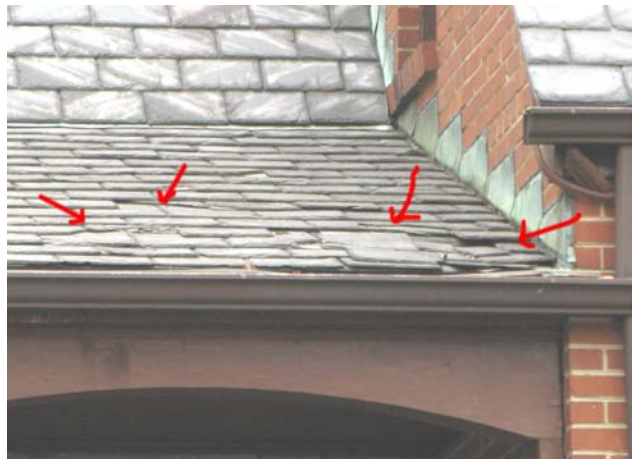
Front porch roof has been leaking at the lower right corner.
Roofing repairs are needed. The roof sheathing may be damaged here.
Further investigation and repairs are needed.

There are other roof slates on the porch and main house that are cracked or broken. The entire roof surface needs to be inspected and repaired by a licensed Roofer.

Front porch roof has been leaking at the lower right corner.
Roofing repairs are needed. The roof sheathing may be damaged here.

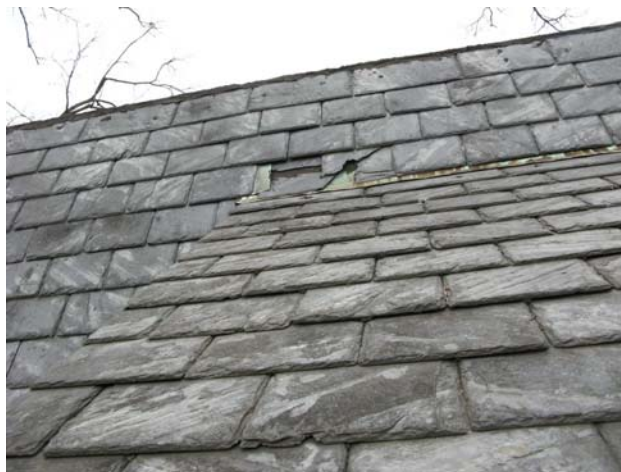
#2 Roof Location= Main House and rear bump out roof surface. The bump out is shedding type of roof. There are cracked or broken off slates on all roof surfaces. There are slates with metal flashings installed under the slates which is a less costly sign of past repairs. There is a damaged area at the rear of the house which is causing leaking to the bedroom ceiling below. Repairs are needed.

There is a damaged area at the rear of the house which is causing leaking to the bedroom ceiling below. Repairs are needed.

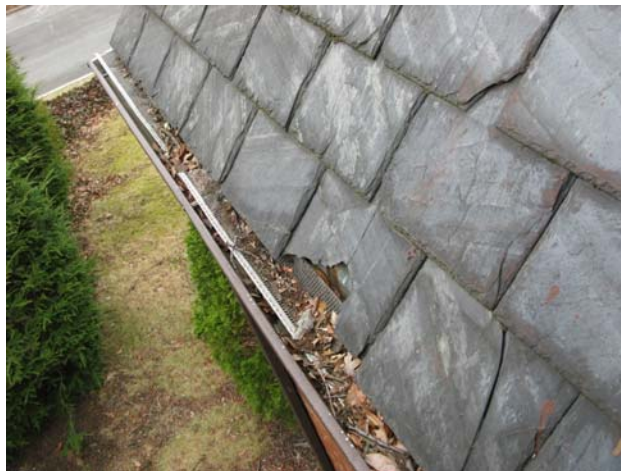
Damaged slates can be seen at all sides of the roof. Repairs are needed.

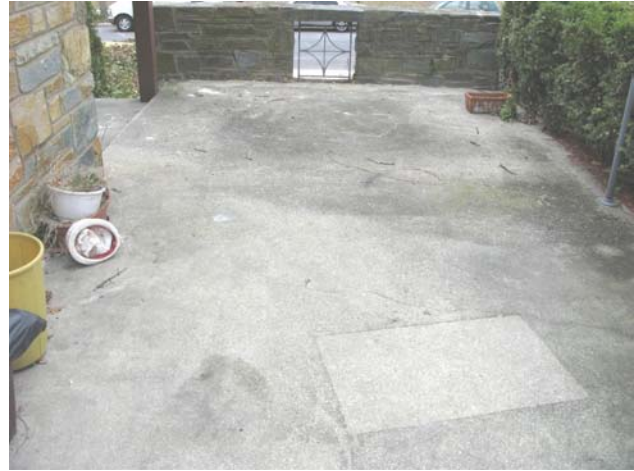
Left house concrete patio surface is also the roof covering for the garage living space area below. This patio has hairline cracking which is leaking to the ceiling of this space. Repairs are needed. Ceiling stains pictured in the basement section of the report.

Left house concrete patio surface is also the roof covering for the garage living space area below.

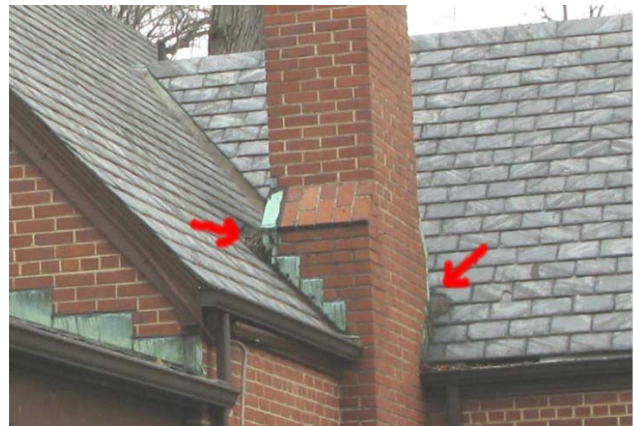
The front roof has a valley which flows down into the chimney. This is a design flaw and leaking is almost expected. There are signs in the attic that this area has leaked in the past. Tar repairs can be seen at the flashing outside. Some dry water stains can be seen on the roof sheathing in the attic at this area. (pictured elsewhere) See attic. This area should be checked for active leaks. Suspect that periodic repairs may be needed here.

The front roof has a valley which flows down into the chimney. This is a design flaw and leaking is almost expected.

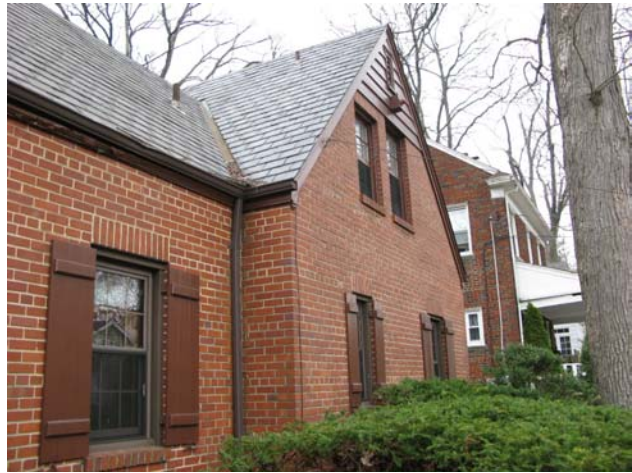
Some sections of valley are covered by leaves and condition could not be seen.
The roof in general needs repairs. All valleys and flashing should be checked by roofer.

Some sections of valley are covered by leaves and condition could not be seen.

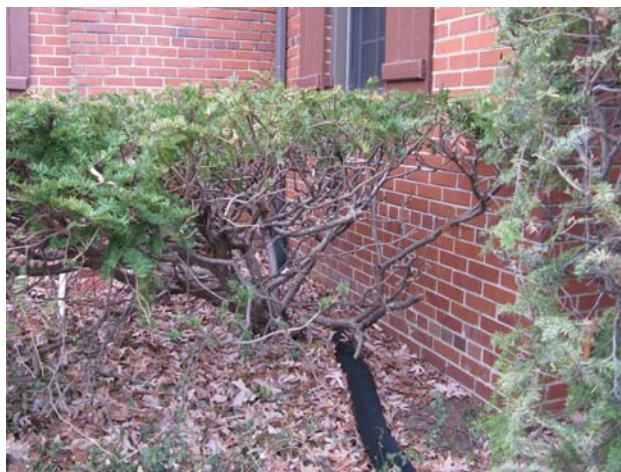
Improper on ground plastic pipe extension is used at house front. The used pipe has holes in the pipe for use as a drain tile. Water will leak out. This on the ground pipe is a trip hazard. Buried storm drain pipe should be installed.

Improper on ground plastic pipe extension is used at house front. The used pipe has holes in the pipe for use as a drain tile. Water will leak out.

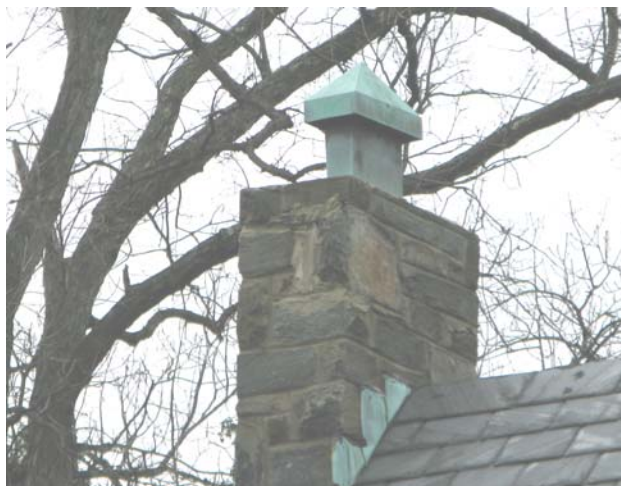
Masonry stone chimney at the left house is for use with the kitchen ceiling exhaust. There are some open mortar joints which need masonry repairs. there are signs that the chimney to roof flashing has leaked or is leaking. Water stains were seen on the ceiling of the left attic storage room. This area should be checked by a roofer.

Masonry stone chimney at the left house is for use with the kitchen ceiling exhaust. There are some open mortar joints which need masonry repairs.

Inspection and repairs are needed by a masonry contractor or licensed chimney sweep.

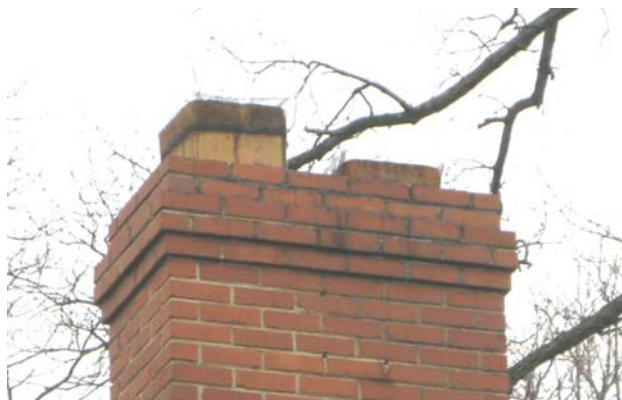
Other = View was limited. The flue needs to be cleaned. The top of the chimney should be checked. Due to age a new mortar crown may be needed.

Rain caps needed, top crown and flues need to be checked.

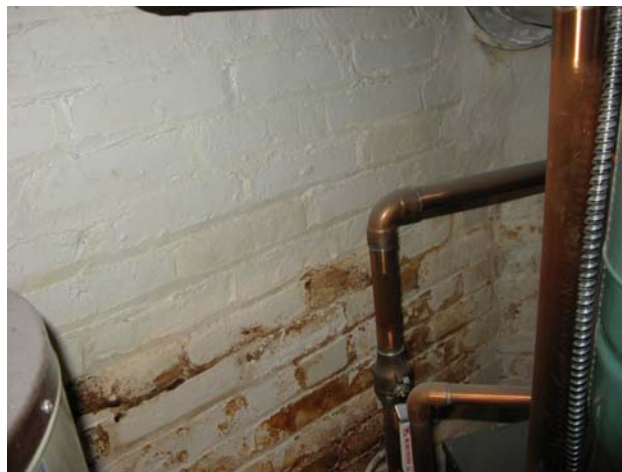
Rain caps need to be installed. There has been water entering the basement from the flues.

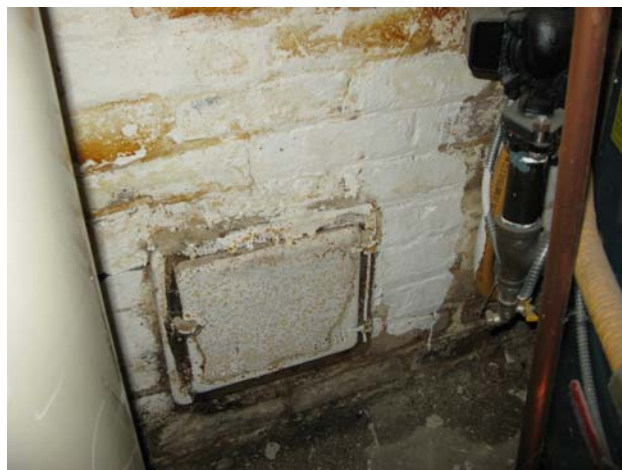
The ash drop clean out door in the basement is stuck shut. This door needs to be made operational.

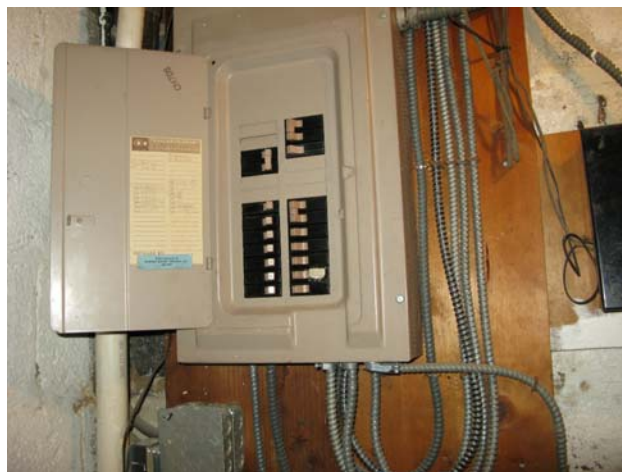
Suggest installing modern panel with a main breaker and more open slots.

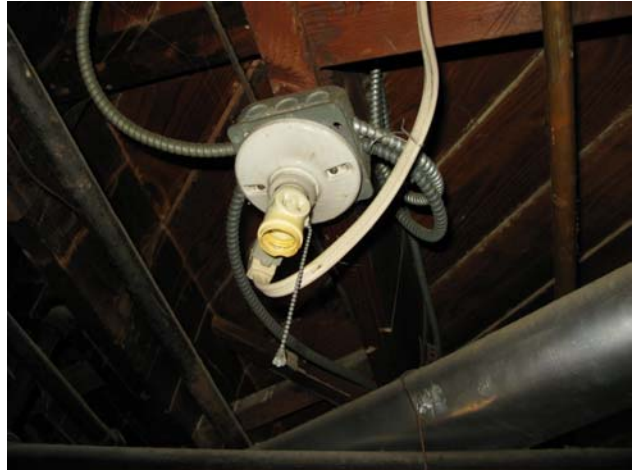
The dryer is being operated from an extension cord connected to a light adaptor. A proper outlet needs to be installed. (safety)

Inspection and Repairs needed by a licensed electrician.

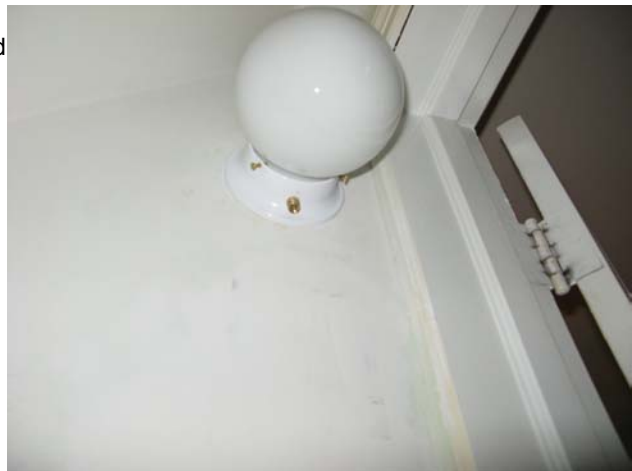
Some house lights were not operable. A few pull chain lights had broken chains. Some fixtures are missing globes.

Some lights with broken pull chains. Repairs needed.

All house lights and fixtures should be inspected and repaired as needed for normal function by a licensed electrician.

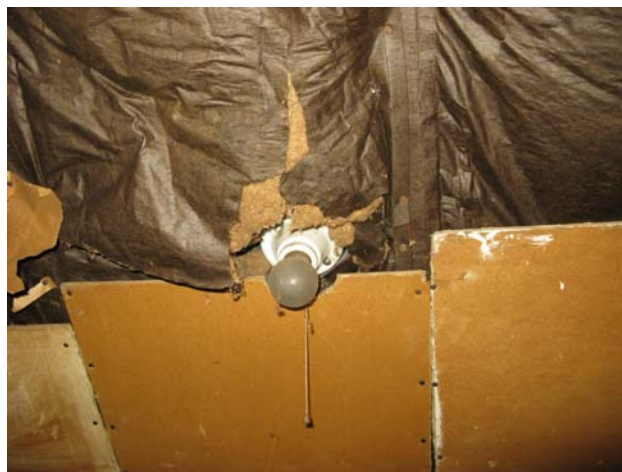
One attic bulb light is contacting paper insulation. (safety)
Repairs needed.

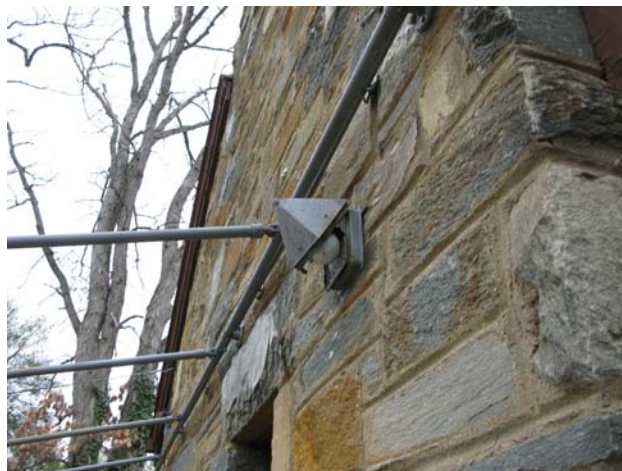
Damaged light fixture at left side of the house. (safety) Repairs needed.

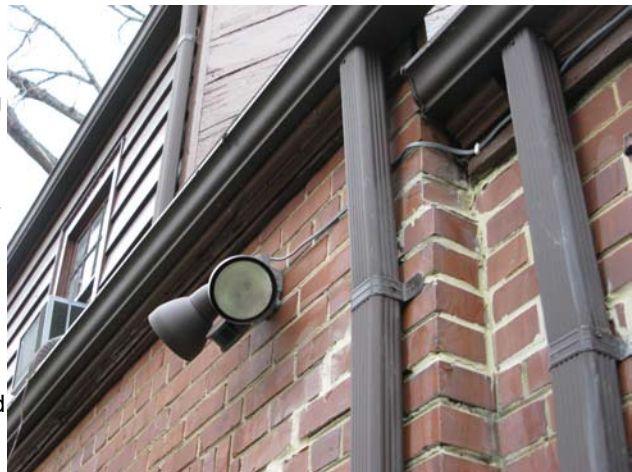
Cracking and house brick wall motion was seen at the rear corner of the house where main house connects to the dining room, kitchen wing. The house brick wall has moved 3/4 inch at this area. The cracking is seen up high on the wall. This is a structural defect. This wall motion has not put the house at current risk of failure. The cracks have been filled with mortar to stop water entry. The actual foundation at this area in the basement could not be seen due to covered walls.

The inspector is not a structural engineer. The inspector is not sure what dynamic has caused this type of cracking. The buyer might want to get further evaluation by a licensed engineer. Even though the house is not at current risk, should the wall continue to move some expensive structural repairs could be needed. Suggest further evaluation.

Motion in the house wall is a structural issue.

Structural Defects were discovered that will need further evaluation by a Licensed Structural Engineer. The evaluate the discovered defects and the house in general. A statement of current condition should be issued and an outline of needed repairs provided.

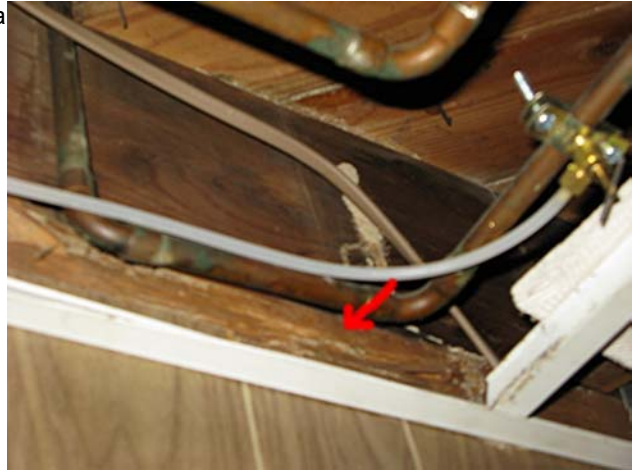
Termite damage was seen on the wood top wall plate at the wall between the garage living space and basement. This is a non support wall. The full extent of the damage could not be evaluated due to wall coverings.

Termite damage seen on basement wall framing near the garage living space.

Repairs to the wall should be by a licensed contractor.

Suggest having the house inspected for active termites by a licensed pest control person.

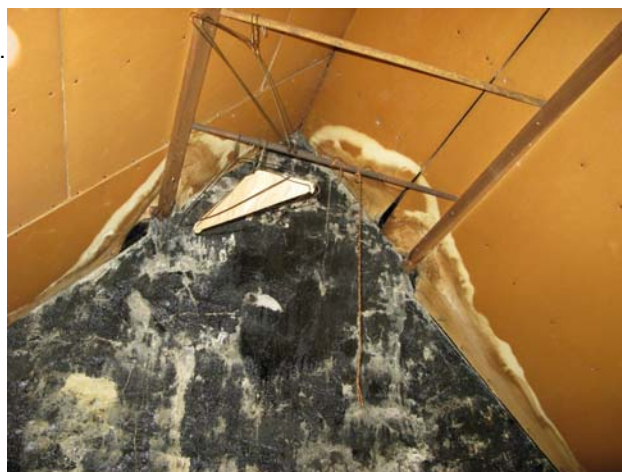
Dry Stains on Attic Sheathing and Framing were viewed.
Stains were seen on the storage room ceiling near the left house chimney. This may be an active leak.
Stained area/s need further investigation by a licensed roofer.

Stains were seen on the storage room ceiling near the left house chimney. This may be an active leak.

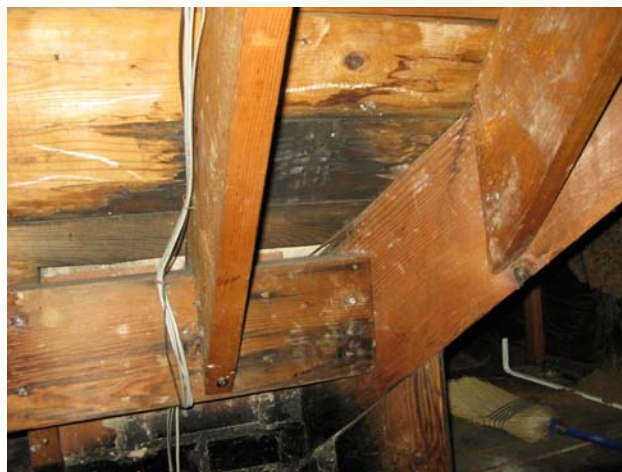
Dry Stains on Attic Sheathing and Framing were viewed. Dry stains were seen on the framing near the front house valley where it slopes down to the chimney. There are signs on the roof here of past leak repairs. Not known if this is current or old staining. Further investigation needed.

Dry stains were seen on the framing near the front house valley where it slopes down to the chimney.

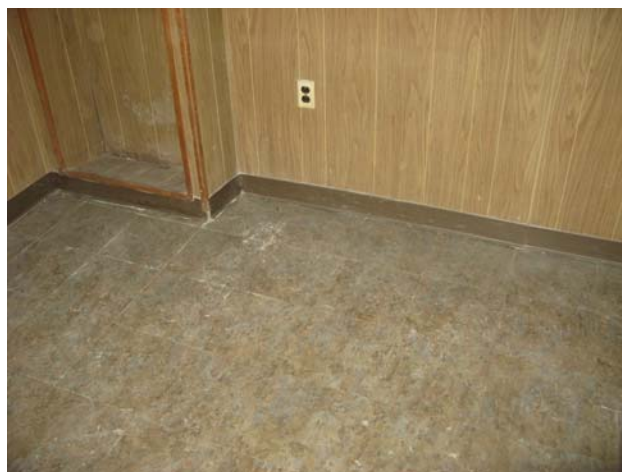
Some signs of Past/Present water entry observed: Water damage and dry water stains were seen on the rear basement walls and floor. Signs of past seepage were seen in the rear of the garage living space area also. (pictured below in this section of the report)

Some signs of Past/Present water entry observed: Water damage and dry water stains were seen on the rear basement walls and floor.

Possible repairs to reduce the risk of basement seepage.

- The garage living space sump pump is not operating. Repairs needed.
- Yard grade needs to be improved next to the house at front center, right and all along the house rear. (Discussed in Detail, elsewhere in report) Key
- Gutters need to be cleared of debris and checked to see that they are in good working order.
- Down spouts need to be extended away from the house and storm drain need to be in good working order.
- Window wells need to be cleared and drains in the wells need to be checked to be sure they are clear.
- Should seepage continue after all the above repairs, additional sections of sub slab French drain would need to be installed.

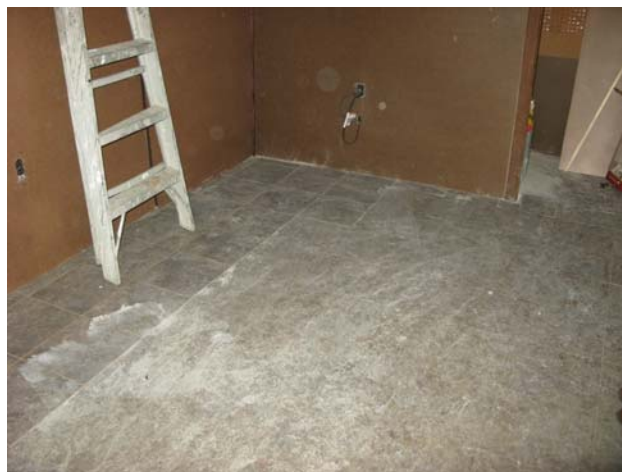
Signs of past seepage were seen in the rear of the garage living space area also.

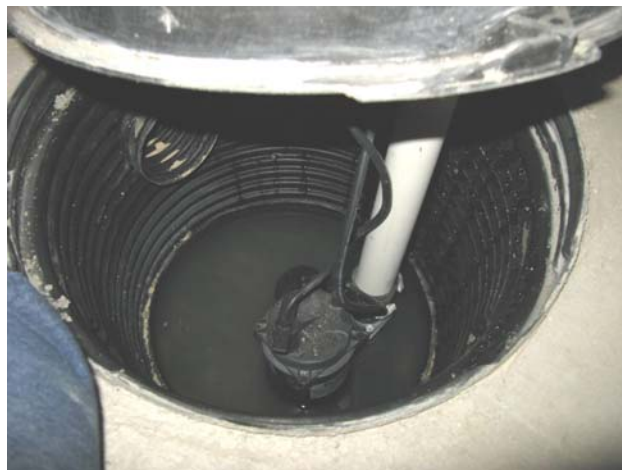
The garage living space area sump pump is running but not pumping. This system is not operable and needs to be repaired.

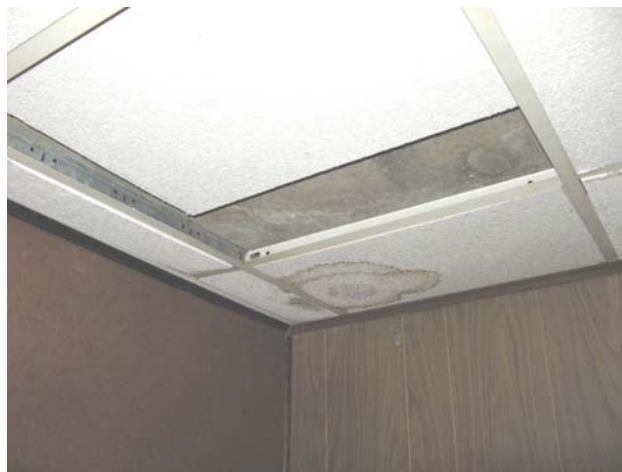
Garage living space ceiling tiles are stained due to cracking in the concrete ceiling slab that serves as the roof for this area. Repairs are needed.

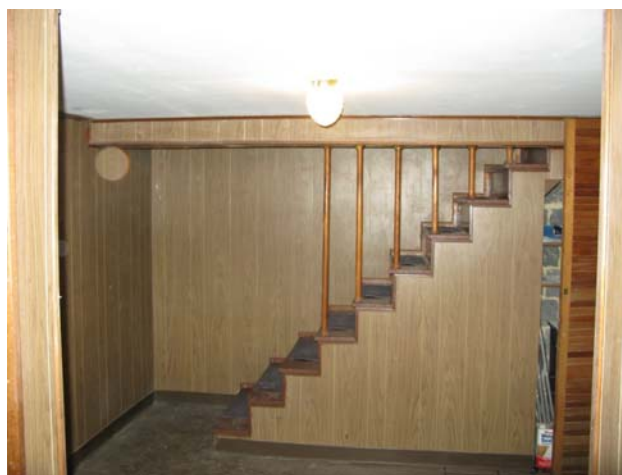
Hand rails are not complete. (Safety) The space between side rail balusters is wide and small children could fall through.(safety)

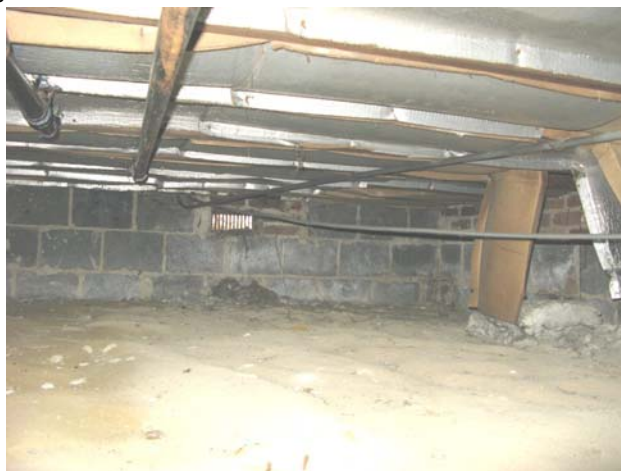
Plastic sheet vapor barrier needs to be installed to all open floor in the crawl space. This will help keep ground dampness from entering house structure.

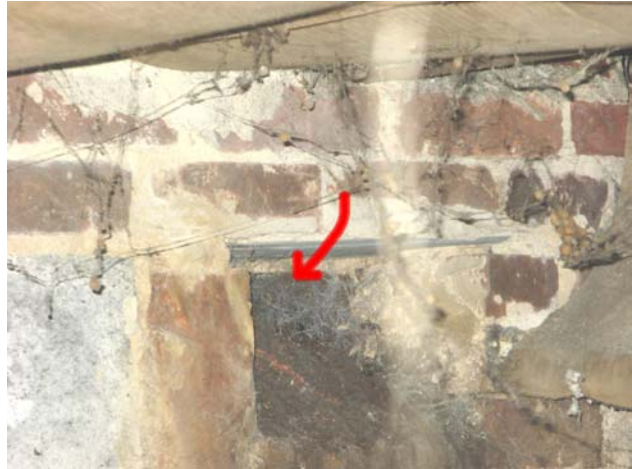
Some wall vents are blocked with dirt. Some signs of water entry through wall vents. Window wells need to be installed

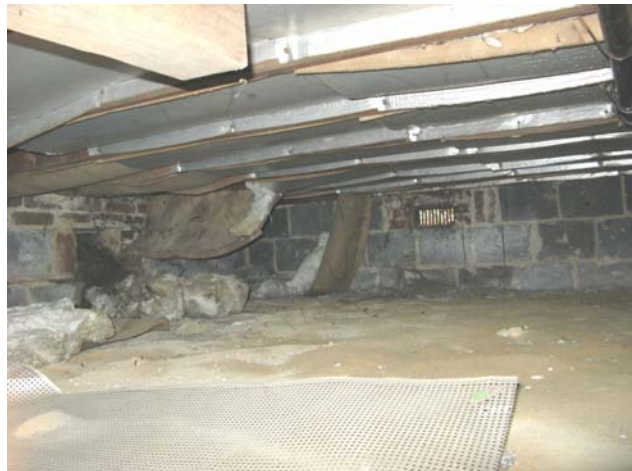
Improper insulation with vapor barrier installed. Some insulation is falling.

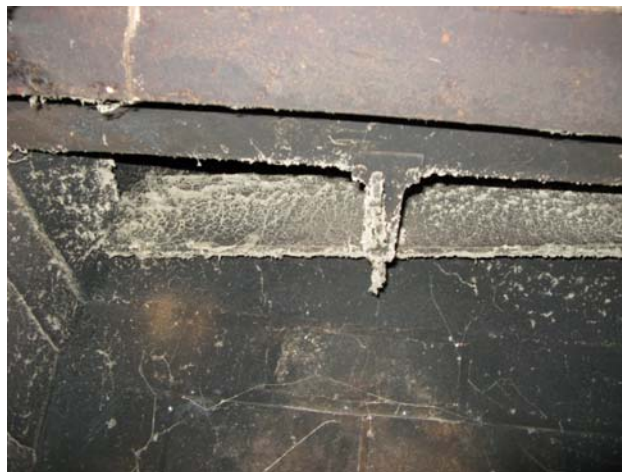
Damper has fallen down out of position and is not operable.
Repairs needed.

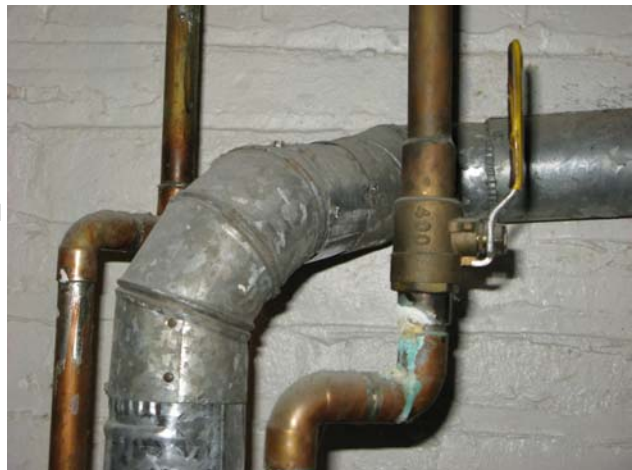
Water pipe leak was seen near the shut off valve above the water heater. Repairs are needed.

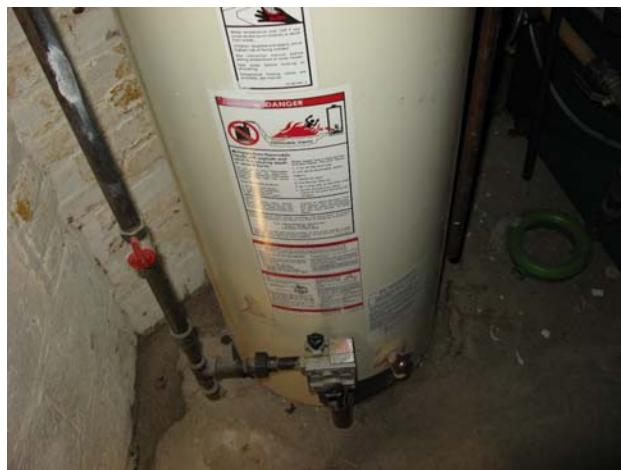
Loud knocking is not normal and this water heater needs to be replaced by a licensed plumber.

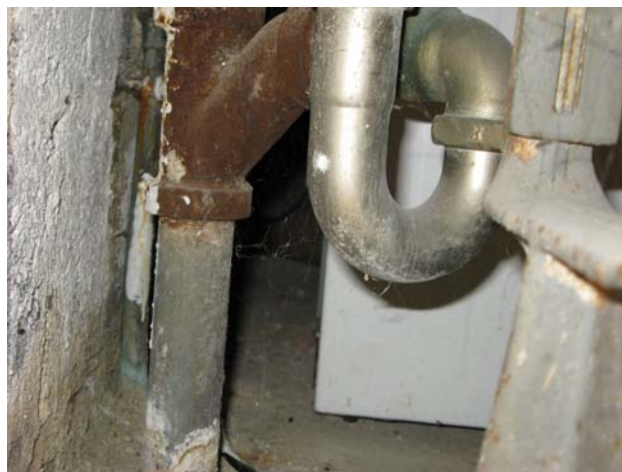
Laundry sink drain is slow and needs to be cleared for normal operation. Laundry sink drain assembly is leaking. Repairs needed.

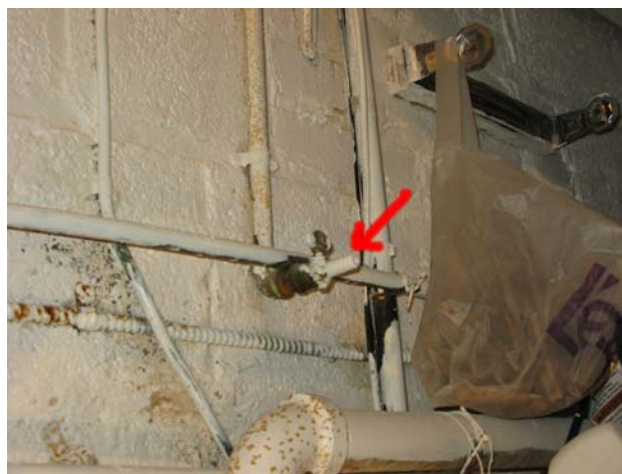
Old, not in use gas pipe with twist valve at end. Laundry area.
This pipe needs to be capped. (safety)

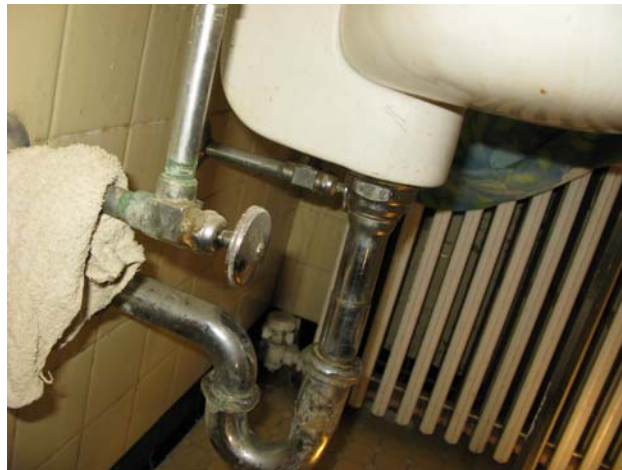
Sink drain assembly has extensive corrosion and needs replacement

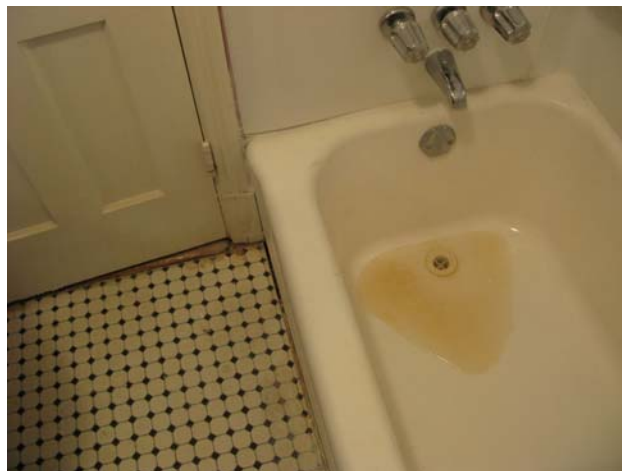
The tub drain backs up when the sink is operated.

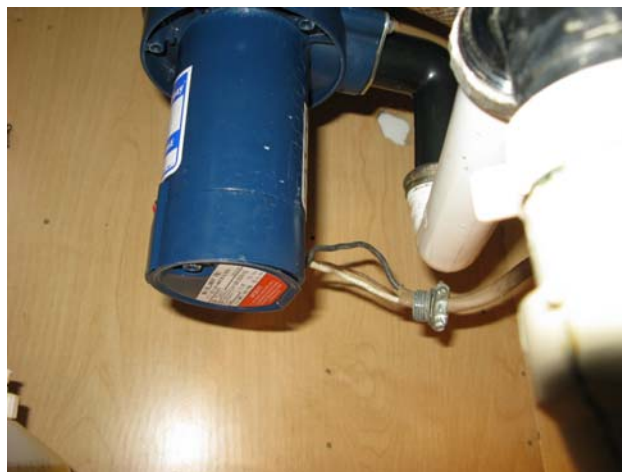
Wire enters disposal, not through approved connector. (Safety)

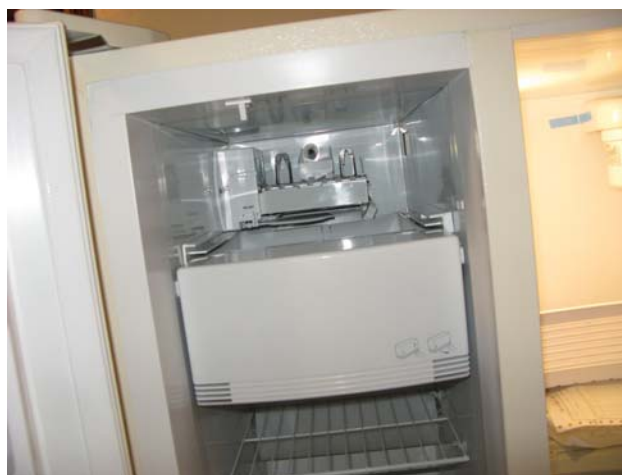
Ice maker was off at inspection, function not known.

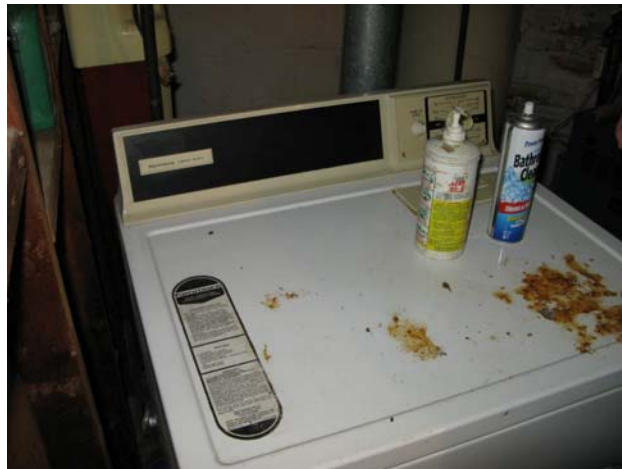
Gas, clothes dryer is aged and not operable. The dryer is disconnected from the vent pipe.

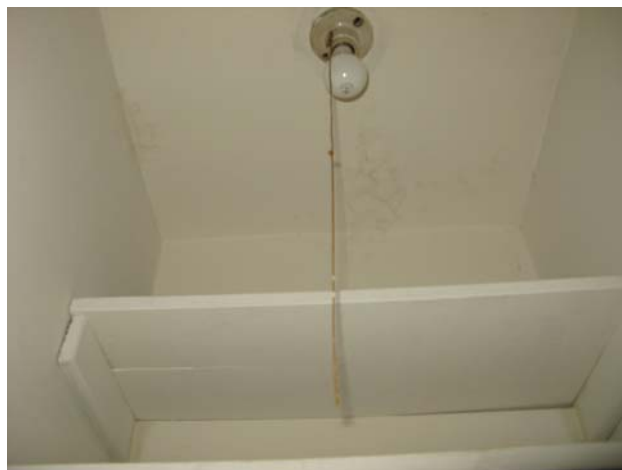
There are roof leak stain on the rear bedroom closet ceiling.
Suspect this is due to damaged roof slates.

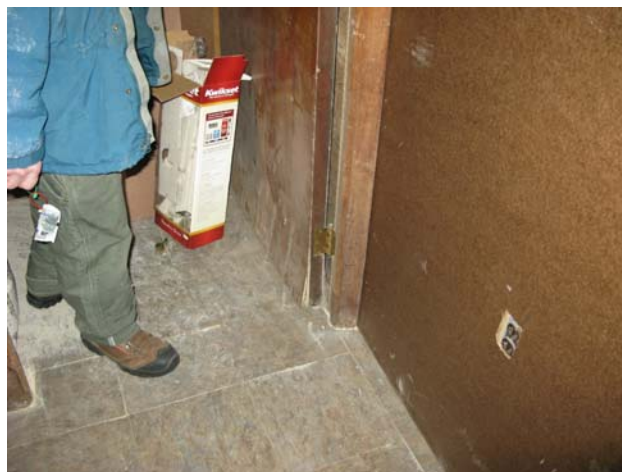
Basement garage living area door has water damage due to seepage. Door replacement needed.

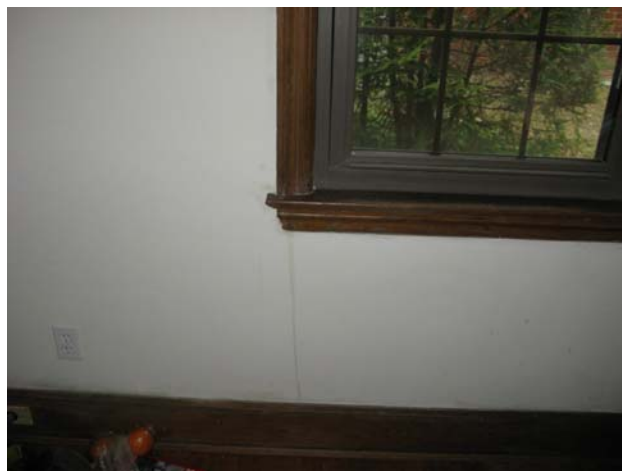
Water has leaked down the wall near the new dining room window. Minor repairs needed.
